BIOENGINEERING / RIPARIAN HABITAT RESTORATION
SHEEP CREEK ROAD KM 5.5

The Provincial Emergency Program
through the Ministry of Transportation and Highways of the Central Kootenay District.
Contract # 310 LM 7544

Pierre Raymond Forest Technologist

July 16, 2001

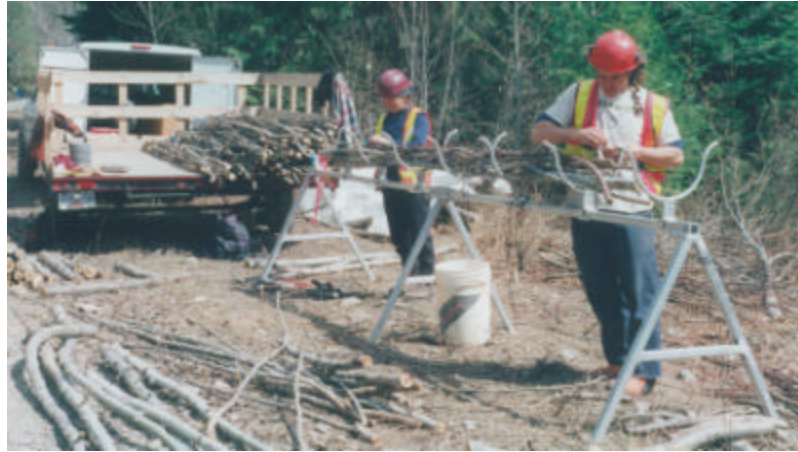
Plate #11; Fascines bundle constructions

A total of 81 fascines / live pole drain bundles were gathered and constructed on site. The dimensions varied from 4 metres in length by 16 to 20 cm in diameter, for the drain fascines and contour fascines, to 4 metres in length by 30 cm in diameter for the live pole drains (see plate # 11, 12). The various fascines and live pole drain bundles were built with an average of 12 to 15 cuttings per bundle, with cuttings varying from 2 to 8 cm in diameter and 1 to 4 metres in length. All fascines and live pole drains were anchored with 15 mm rebar x 0.6 m and 15 mm rebar x 1.3 m with a "T" (6" cross piece) welded at one extremity to insure firm placement. The cuttings gathered for the wattle fences were 19 regular bundles of 12 stems per bundle varying from 2 to 8 cm in diameter and 2 to 4 metres in length. As well, 820 stakes of 0.6 meter, 245 stakes of 0.8 meters, 148 stakes of 1.0 meters and 400 stakes of 1.5 metres were gathered. The stakes varied from 2 to 15 cm in diameter. Each modified brush layers was built using 20 cuttings of 0.6 m and anchored with 2, 15 mm rebar x 1.3 m placed in front of a 1" x 8" board of 6.5' in length. The live materials were transported and stored in Sheep Creek adjacent to about 3km on the Sheep Creek road. They were enclosed within a metal fence supported by rebar to protect the live cuttings from beaver damage. All live materials were stored in water for a period varying from 6 up to 8 days to help promote root initialization. (see plate #13).
